53. History of Flight: B-25E, No. 44-29125 departed Nellis Air Force Base Nevada on 30 January 1956. The purpose of the flight was aircraft parts pick-up at Olmsted Air Force Base Pennsylvania, and delivery of two passengers to Andrews Air Force Base Maryland. The crew consisted of Major William L. Dotson, pilot, Captain John F. Jamieson, pilot, Captain Steve W. Tabak, pilot, Staff Sergeant Walter E. Sooccy, Crew Chief, and Airman Second Class Charles L. Smith, Crew Chief; Captain J. P. Ingraham and Master Sergeant Alfred J. Alleman were listed as passengers. The aircraft departed Nellis Air Force Base at approximately 1815E and arrived at Tinker Air Force Base Oklahoma at 2221E. The crew decided to ROM at Tinker Air Force Base in view of ice and snow reported on runways at Selfridge, the next point of destination, and brake trouble discovered on the aircraft. A new right brake assembly and left outboard brake assembly were installed. The aircraft was refueled at Tinker Air Force Base with 560 gallons of 100 octane fuel for a total of 975 in the tanks. Flight was resumed on 31 January 1956, departing Tinker Air Force Base at 0853E and arrived at Selfridge at 1313E. Major William L.

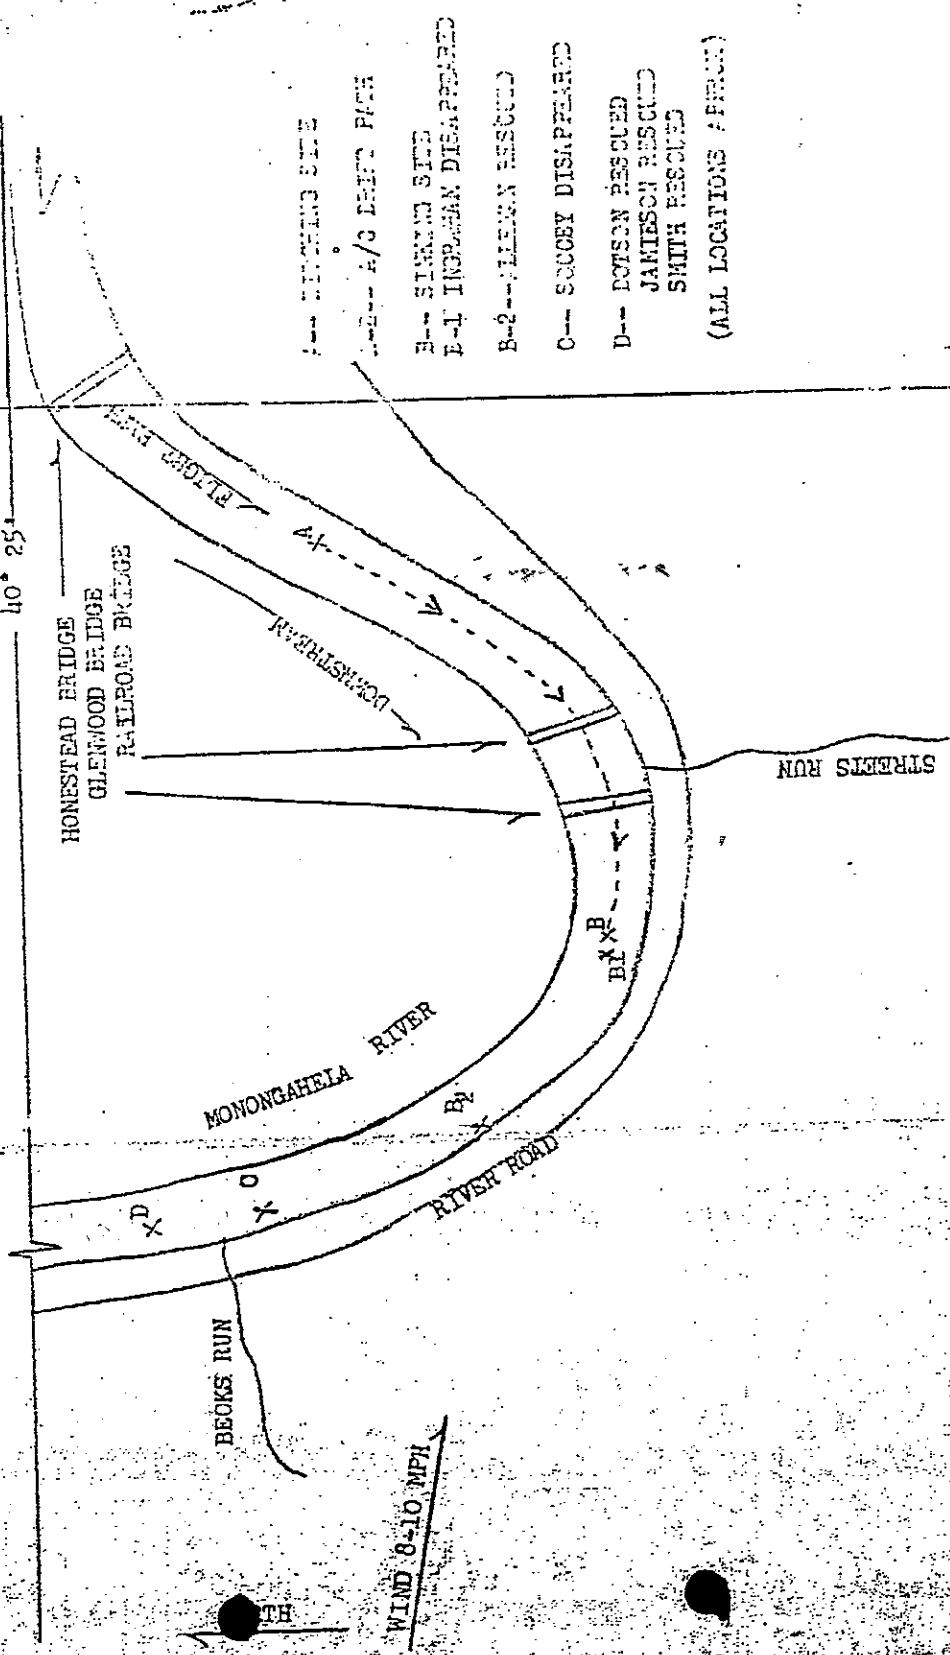
[REDACTED] Captain Jamieson transmitted a "Mayday" which was overheard at the Allegheny County Tower at 1609E on either 126.18Mc or 257.8Mc. Major Dotson lowered wing flaps and completed a wheels-up touchdown, heading downstream in a generally south, southwest direction at approximately 1610E to 1611E. The ditching was successful and all occupants evacuated the aircraft with no apparent injuries. All six persons were able to climb aboard the upper surfaces of the aircraft as it floated down the stream. The Monongahela River at this point varies from 800 to 1000 feet in width; the river depth varies from 25 to 35 feet. The current was estimated to be approximately 8 to 10 knots; the recorded water temperature was 35 degrees F; the recorded air temperature was 27° F; the recorded wind velocity was 8 to 10 knots, from the northwest. The aircraft remained afloat for an estimated 10 to 15 minutes.

[REDACTED] Subsequently, [REDACTED] Sergeant Soocey swimming toward the left bank and disappear beneath the water approximately 60' from the shore. The aircraft drifted for an estimated [REDACTED] mile from the point of impact prior to sinking. Major Dotson and Airman Smith, the last personnel to be recovered were recovered approximately 1½ to 2 miles from the scene of impact. At the time of this report neither the aircraft nor missing personnel have been located.

- A--- DIVING SITE
- B-2--- A/C DUFF PITCH
- B--- SINKING SITE
- B-1--- IMPROPER DISAPPEARED
- B-2--- ALLEN RESCUED
- C--- SACCEY DISAPPEARED
- D--- DOTSON RESCUED
- JAMESON RESCUED
- SMITH RESCUED
- (ALL LOCATIONS APPROX)
